butte landing

AREA STRUCTURE PLAN

TITLE Butte Landing Area Structure Plan

BYLAW NO. 942-24

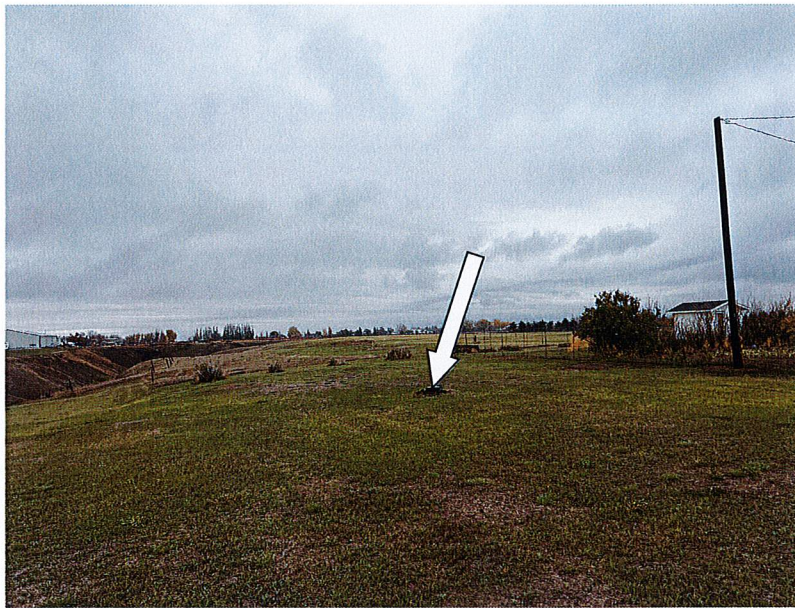
Photograph 2 – Looking east along north property line. Note catch basin Previously installed in preparation for storm sewer connection (arrowed)
